PROJECT CHALLENGER: REAREND REVIVAL

WANT ANOTHER 40 YEARS OUT OF YOUR MOPAR 8.75-INCH REAR? WE DO! HERE'S WHAT TO LOOK FOR WHEN YOU DIVE INTO THAT AXLE.

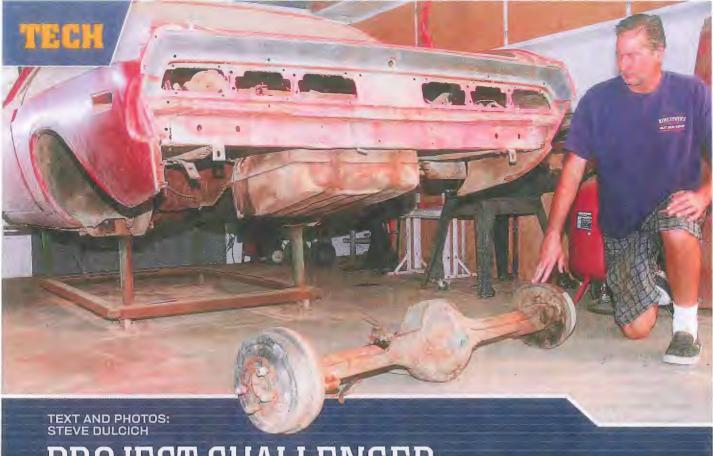
begins with the axleshafts, which requires removing the brakes. Our drums weren't too stubborn, but sometimes backing off the brake shoe adjuster is required. The axleshaft flange has an access hole to get to the five retainer bolts with a socket.
