MOPAR MUSCLE.COM  
JANUARY 2015 VOL. 28 NO. 1

# TAIL ART

WHEN NEW PARTS AREN'T AN OPTION, RESTORE YOUR MOPAR'S TAILLIGHT PANEL YOURSELF. WE SHOW HOW ON A '71 R/T CHALLENGER.

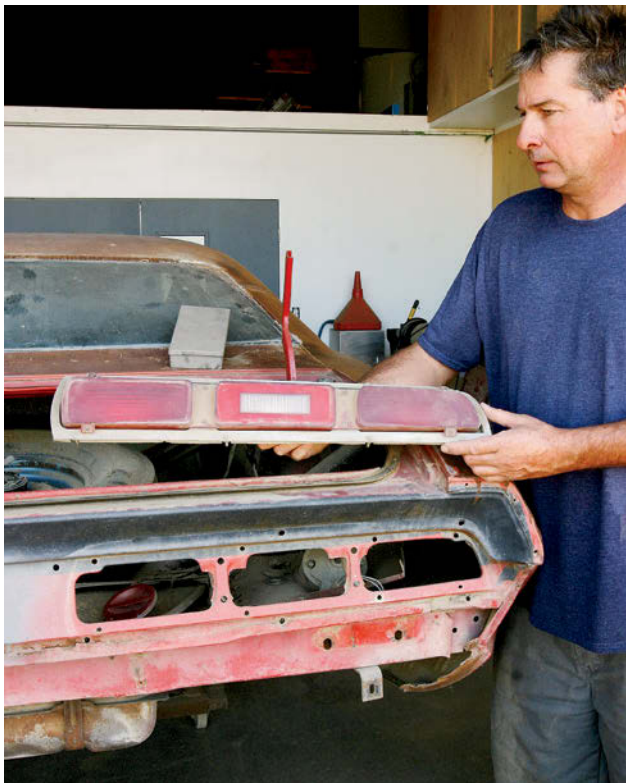
The taillamp housings and the trim bezel are completely separate assemblies. The trim panel unbolts from inside the trunk, and once removed the taillamp housings and lenses can be unbolted and removed. The bulb sockets are integral with the rear wiring harness and simply pull out of the taillamp housings.

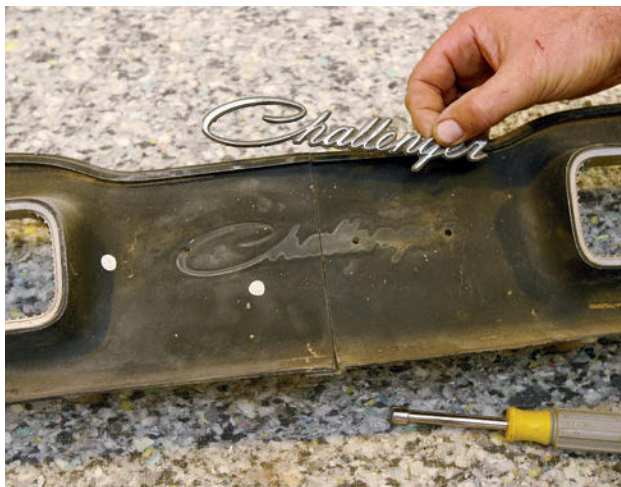
The trim panel is actually made up of two separate pieces that overlap and attached in the center via two delicate peened attachments. When off the car these can easily break, which will undoubtedly fracture the Challenger script emblem that bridges the two. Ours survived intact, and even the Challenger emblem was in very nice condition.

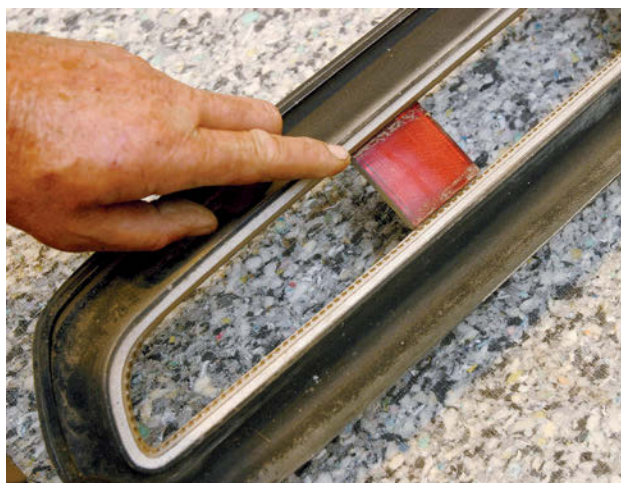
The trim panel simply overlays the taillamp lenses, and features four delicate reflectors built into the framework, which give the illusion of full-width taillamps, even though the lenses actually have three distinct segments. It is a very unusual arrangement.

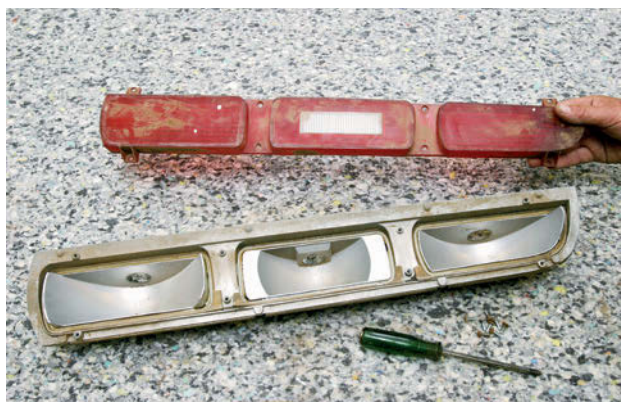
Our lenses and housings were in exceptional shape and just needed cleaning and polishing. Rougher examples will need abrasive blasting and refinishing of the bright silver reflective paint inside the housings.

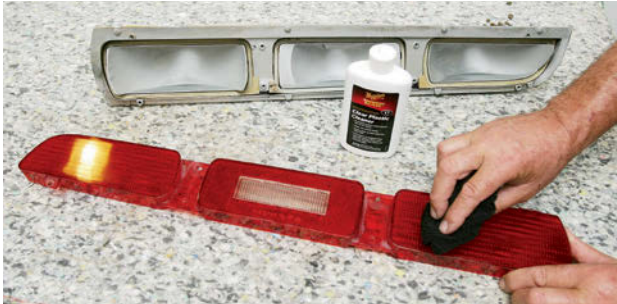
Meguiar's Clear Plastic Cleaner applied by hand was enough to bring a bright red gloss to our original lenses. If the lenses are heavily oxidized, we have had success with the same product and machine buffing.

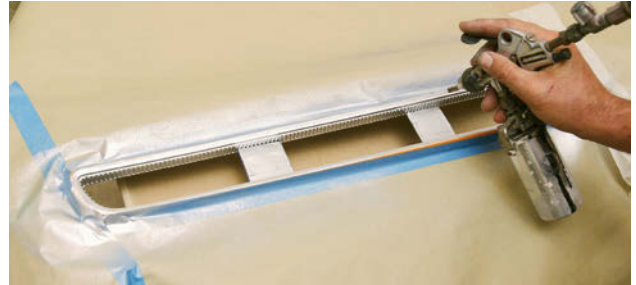
Next, the entire panel was taped, leaving the light argent taillight surrounds. Use high-quality masking tape to ensure a good edge. The paint here is a PPG fine aluminum metallic tinting base mixed by our local PPG jobber.

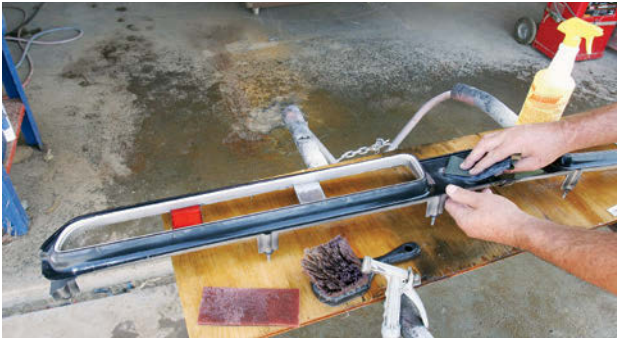
The trim panel was still wearing the original paint, and other than the paint wearing thin, there was no real damage. We simply needed to clean the part with strong detergent, and give it a scuff with a Scotch-Brite pad. Minor scratches and blemishes were sanded with #400 wet or dry paper.

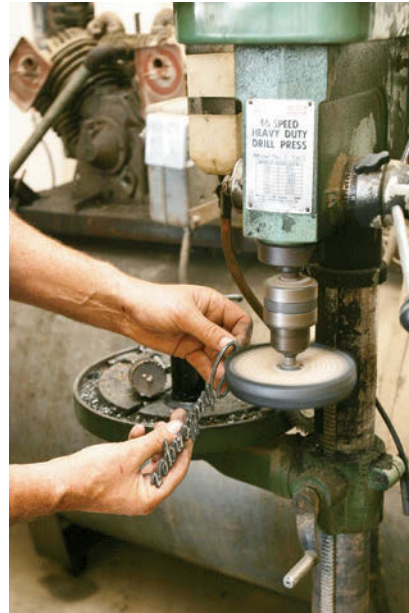
We were able to restore the center Challenger script emblem, since there was virtually no pitting of the chrome. Step one was polishing with Eastwood buffing compound using an Eastwood buffing wheel mounted to our drill press and set to high rpm. Once polished, the emblem was cleaned, and painted black. Once the paint was dried to tack free, we carefully wiped the paint with lacquer thinner to expose the chrome.

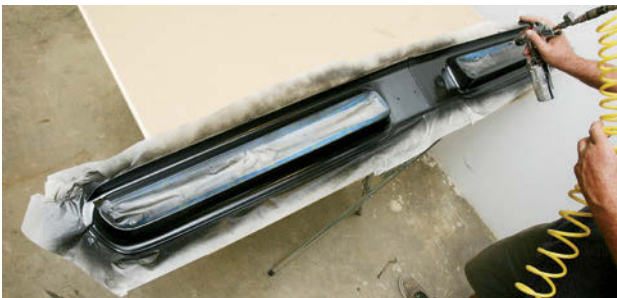
We masked the panel to prevent overspray to the backside and argent areas for paint. A Harbor Freight Tools touch up gun was used to shoot PPG Satin black single-stage urethane.

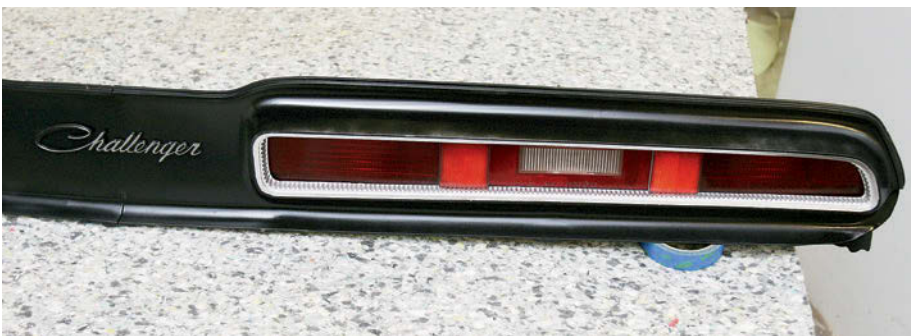
The freshly restored taillamps and rear bezel will impart a dramatic look to our Challenger project when completed. For now we will be stacking up various subassemblies as we restore them, waiting their turn for installation when our Challenger finally comes together.
